# Tensile Behavior of $\text{Al}_2\text{O}_3/\text{FeAl} + \text{B}$ and $\text{Al}_2\text{O}_3/\text{FeCrAlY}$ Composites

S.L. DRAPER, B.J.M. AIKIN, and J.I. ELDRIDGE

The feasibility of  $\text{Al}_2\text{O}_3/\text{FeAl} + \text{B}$  and  $\text{Al}_2\text{O}_3/\text{FeCrAlY}$  composites for high-temperature applications was assessed. The major emphasis was on tensile behavior of both the monolithics and composites from 298 to 1100 K. However, the study also included determining the chemical compatibility of the composites, measuring the interfacial shear strengths, and investigating the effect of processing on the strength of the single-crystal  $\text{Al}_2\text{O}_3$  fibers. The interfacial shear strengths were low for  $\text{Al}_2\text{O}_3/\text{FeAl} + \text{B}$  and moderate to high for  $\text{Al}_2\text{O}_3/\text{FeCrAlY}$ . The difference in interfacial bond strengths between the two systems affected the tensile behavior of the composites. The strength of the  $\text{Al}_2\text{O}_3$  fiber was significantly degraded after composite processing for both composite systems and resulted in poor composite tensile properties. The ultimate tensile strength (UTS) values o

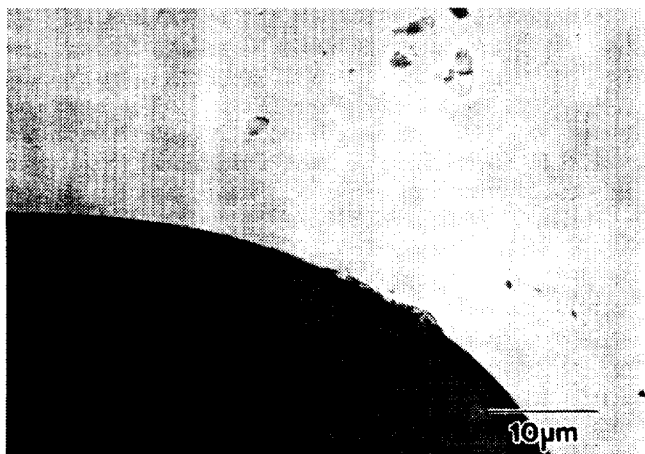
Fig. 2—Microstructure of (a)  $\text{Al}_2\text{O}_3/\text{FeAl} + \text{B}$  and (b)  $\text{Al}_2\text{O}_3/\text{FeCrAlY}$  interface after annealing at 1250 K for 200 h.

The composites were annealed in flowing argon at 1250 K for 200 hours to determine chemical compatibility between the matrices and fibers. Analysis of the  $\text{Al}_2\text{O}_3/\text{FeAl} + \text{B}$  sample indicated a significant amount of carbon contamination due to the binder used in processing. During annealing, the C segregated to some of the matrix-fiber interfaces and formed a C-Fe-Al phase. However, the remaining fiber/matrix interfaces were clean, with no reaction product visible by SEM (Figure 2(a)). Aside from the reactions due to C contamination, the  $\text{Al}_2\text{O}_3/\text{FeAl} + \text{B}$  system showed little or no reaction. Reaction products were observed intermittently around the circumference of the  $\text{Al}_2\text{O}_3$  fibers in  $\text{FeCrAlY}$  (Figure 2(b)). The reaction products were less than 1- $\mu\text{m}$  thick after annealing at 1250 K for 200 hours. These reaction products consisted of various ratios of Fe:Cr:Al or Al:Y:Cr.

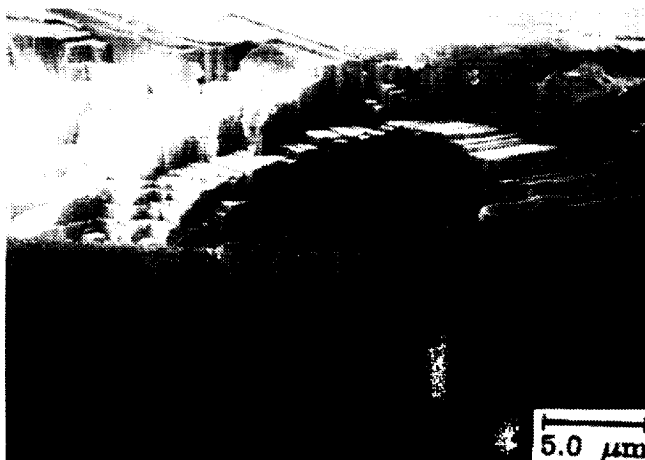
Fig. 7—(a) Surface morphology of  $\text{Al}_2\text{O}_3$  fiber etched from FeAl + B, and (b) fracture initiation site of  $\text{Al}_2\text{O}_3$  etched from FeAl + B.
